**Influence of the coefficient of thermal expansion
mismatch on the bond strength of bi-layered all
ceramic system**

**Inaugural-Dissertation
zur Erlangung des Doktorgrades
der Zahnheilkunde**

**der Medizinischen Fakultät
der Eberhard Karls Universität
zu Tübingen**

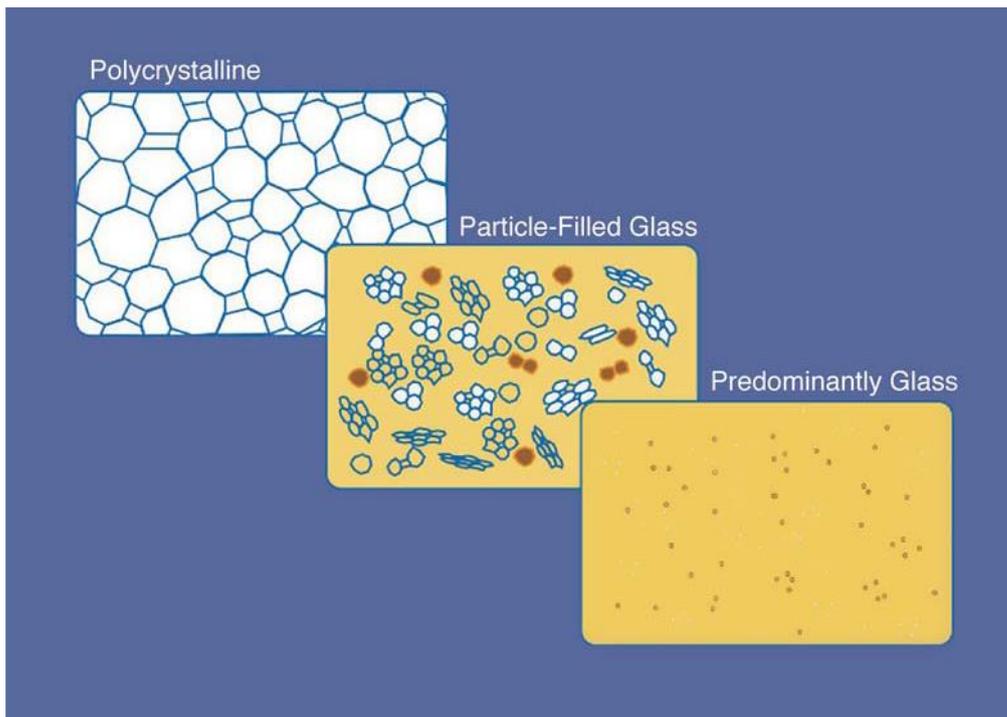
Figure 1. Schematic representation of three basic classes of dental ceramics (Kelly, 2008).

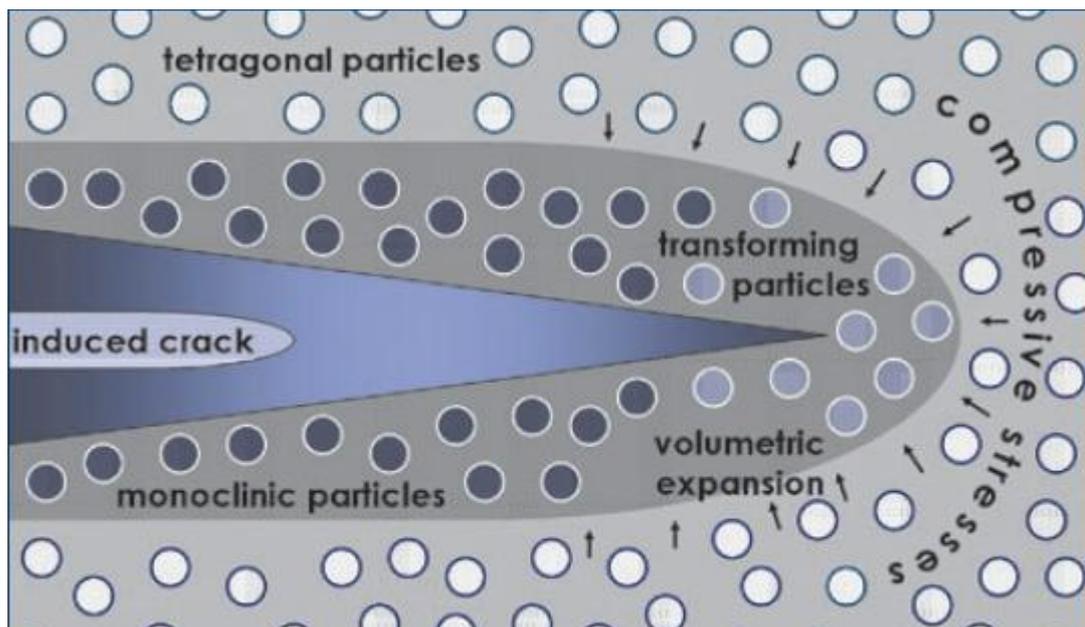
Figure 1.2: Toughening mechanism of the zirconia when the crack is induced (Vagkopoulou et al., 2009)

Zirconia is a polymorphic material, which occurs in three crystallographic forms according to the temperature. Monoclinic structure exists at room temperature and upon heating up to $1170^{\circ}C$. Tetragonal phase occurs between $1170^{\circ}C$ and $2370^{\circ}C$. Above $2370^{\circ}C$ up to melting point, the structure is cubic. During cooling phase of the zirconia, the transformation from tetragonal to monoclinic structure occurs with 3-5% increase in volume (Figure 1.2). The volume expansion, associated with this transformation, leads to the development of internal stress that can break the zirconia into pieces at room temperature. Controlling the internal stress by adding of stabilizing oxides (e.g. MgO , CeO_2 , Y_2O_3) helps to retain the tetragonal structure at room temperature, which leads to arresting crack propagation, which increases the fracture toughness of the zirconia (Figure 1.2). The toughening mechanism does not prevent the progression of a crack; it just makes it harder for the crack to propagate **(Denry & Kelly, 2008; Piconi & Maccauro, 1999).**

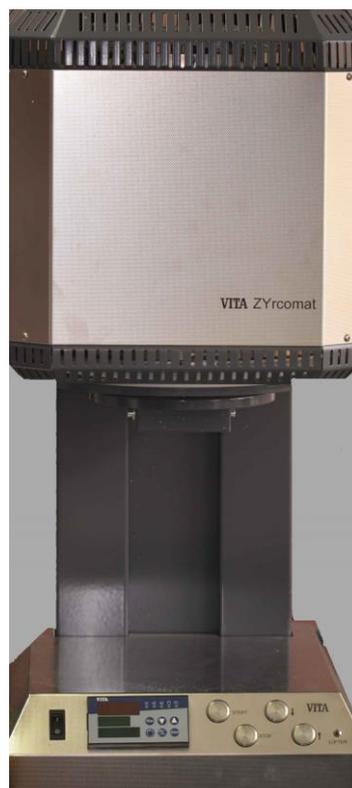
Figure 3.1: Vita Zyrcomat furnace (Vita Zahnfabrik, Bad Säckingen, Germany).

50 rectangular plates of white zirconia have been designed, manufactured, and provided by the company Wieland in pre-sintered white zirconia blank. The specimens then were trimmed from the blank, and the measurements were prepared with calculating the shrinkage factor to compensate the shrinkage after the final sintering process. Firing protocols have been carried out according to the manufacturers' recommendations (Table 3.2) in Vita Zyrcomat furnace (Vita Zahnfabrik, Bad Säckingen, Germany) (Figure 3.1).

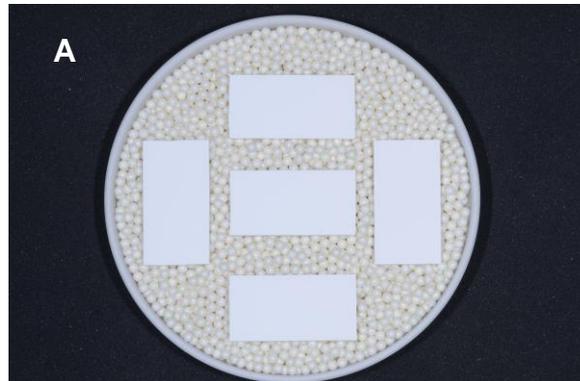
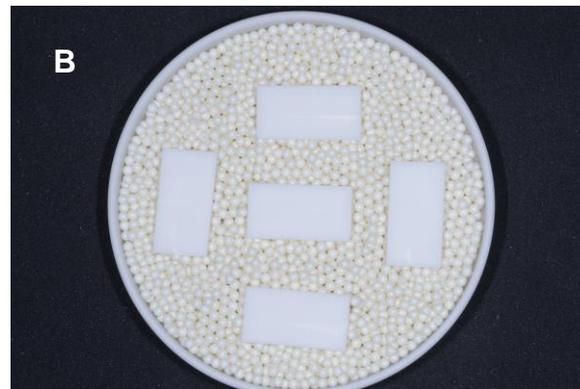
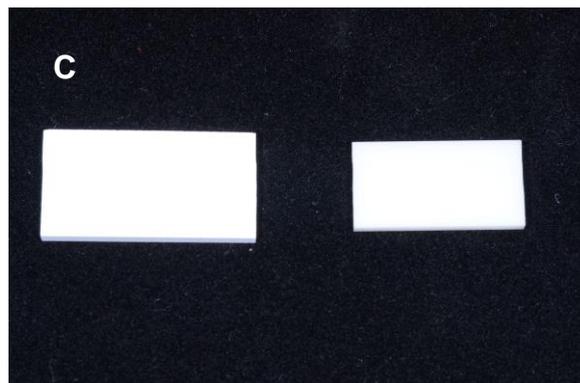
Figure 3.2: A) Zirconia plates before sintering process. B) Zirconia plates after sintering. C) Size of zirconia plate before and after sintering.

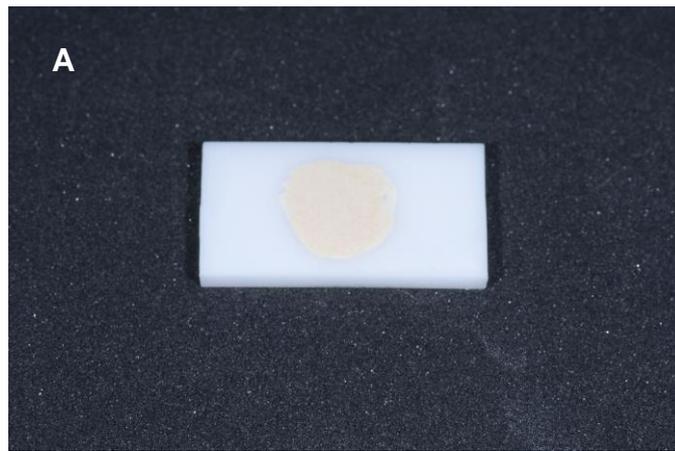
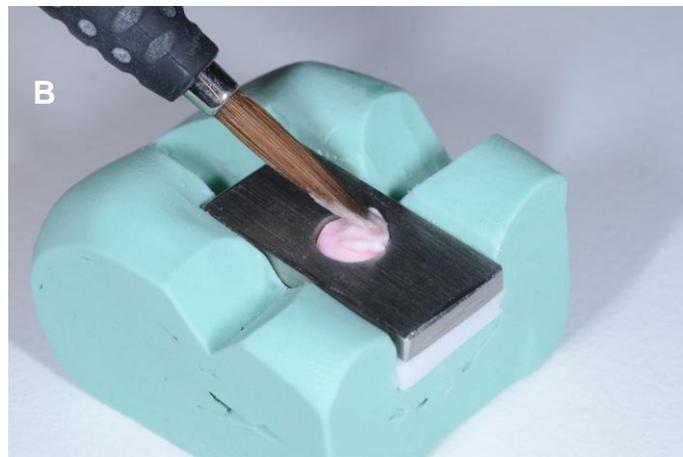
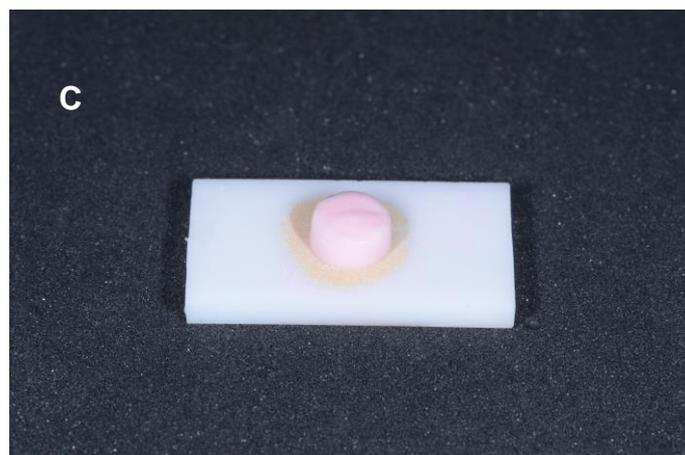
Figure 3.3: A) application of first and second liner. B) veneering ceramic application. C) veneering ceramic before sintering process.

The preparation process of the veneering layer has been done through 5 steps: 1st, 2nd Liner, 1st, 2nd Dentine and Glazing. For all veneering ceramic types, the firing protocol for each step was carried out in a dental furnace Austromat 624 (DEKEMA, Freilassing, Germany) according to the manufacturer's recommendations (Table 3.4). For each group, a thin layer of the respective liner was applied to the zirconia plates and fired according to the manufacturer's recommendations. The second layer of liner was applied and fired under the same condition to achieve a continuous thin layer of the liner (Figure 3.3 A). For dentin layer, a stainless steel mold was placed on the zirconia plates where clearance of 5 mm diameter and 3 mm height was available above the zirconia plates.

The inner surface of the mold was isolated with isolating fluid (Carat, Hagar und Werken, Duisburg, Germany) to avoid the adhesion of the ceramic powder to the mold surface during dentin layering process. The veneering ceramic powder was mixed with an appropriate amount of respective liquid as in common dental lab. The slurry mixture was then poured to the mold (Figure 3.3 B) and the excess liquid was absorbed with tissue paper. After applying the dentin layer, the mold was carefully removed (Figure 3.3 C) and the non-sintered specimens were then fired according to the manufacturer's recommendations (Table 3.4). Under the same conditions, a second dentin layer was added and fired to compensate the shrinkage of the sintering process and to establish the correct diameter and thickness of the specimens (Figure 3.3 D). Finally, a glaze firing was carried out according to the manufacturer's recommendations (Table 3.4). Figure 3.3 illustrated briefly the process of specimens' fabrication and the final sample shape before testing.

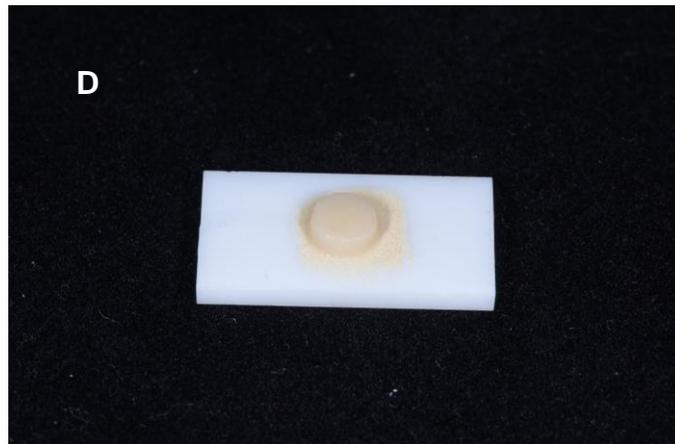
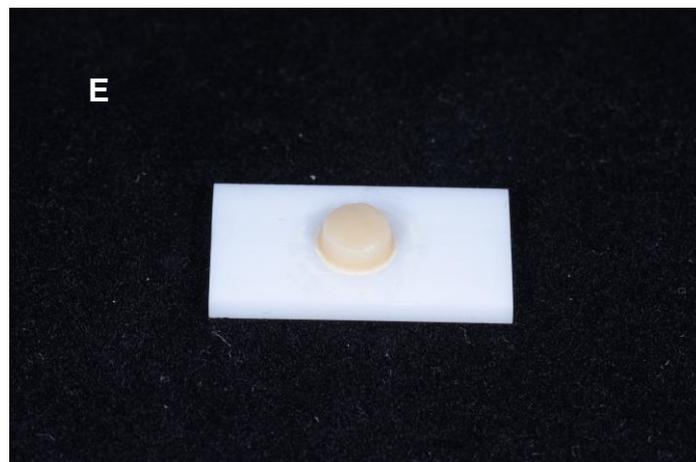
Figure 3.3: D) specimen shape after applying and firing the second dentin layer.
E) the final shape of the specimen before testing.

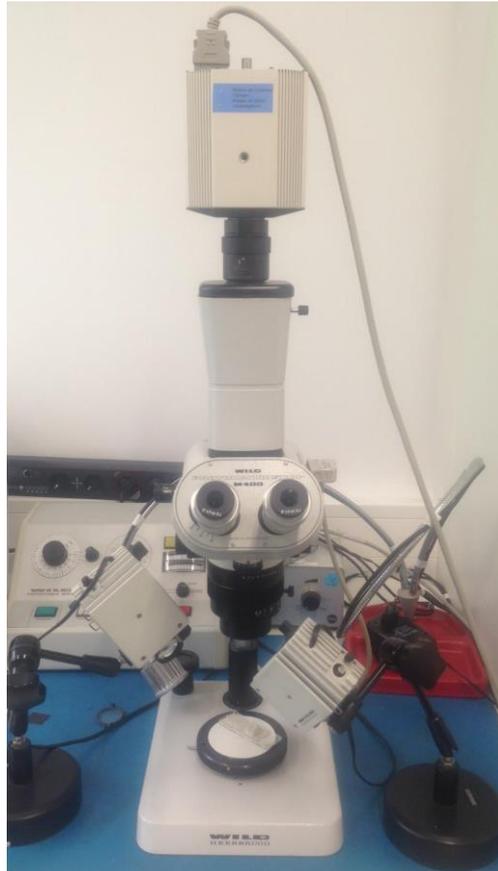
Figure 3.4: Photomakroskop M400 (Wild Heerbrugg, Gais, Switzerland)

Prior to the shear bond strength, the veneered area of all specimens were examined with Photomakroskop M400 (Wild Heerbrugg, Gais, Switzerland) (Figure 3.4) and measured in (mm²) using software Image Pro. Plus v.6 (Media Cybernetics, Washington, USA).

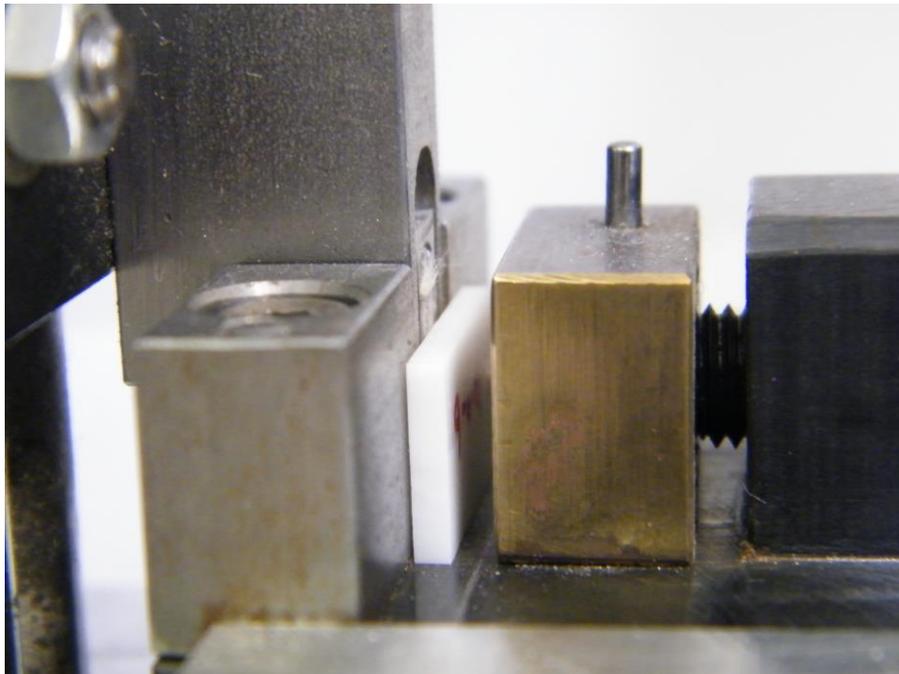
Figure 3.5: Universal testing machine Z010 (Zwick, Ulm, Germany)

The completed spacimens were fixed in a special sample holder and placed in a universal testing machine Z010 (Zwick, Ulm, Germany) (Figure 3.5). The specimens were then loaded with a shear force applied as close as possible to the interface between the veneering ceramic and the zirconia. The shear force was applied with crosshead speed of 1 mm/min

until the fracture occurred. The load at fracture was recorded in Newton (N). For each group, the mean bond strength (MPa) was calculated through dividing the load at fracture (N) by the bonding area (mm²).

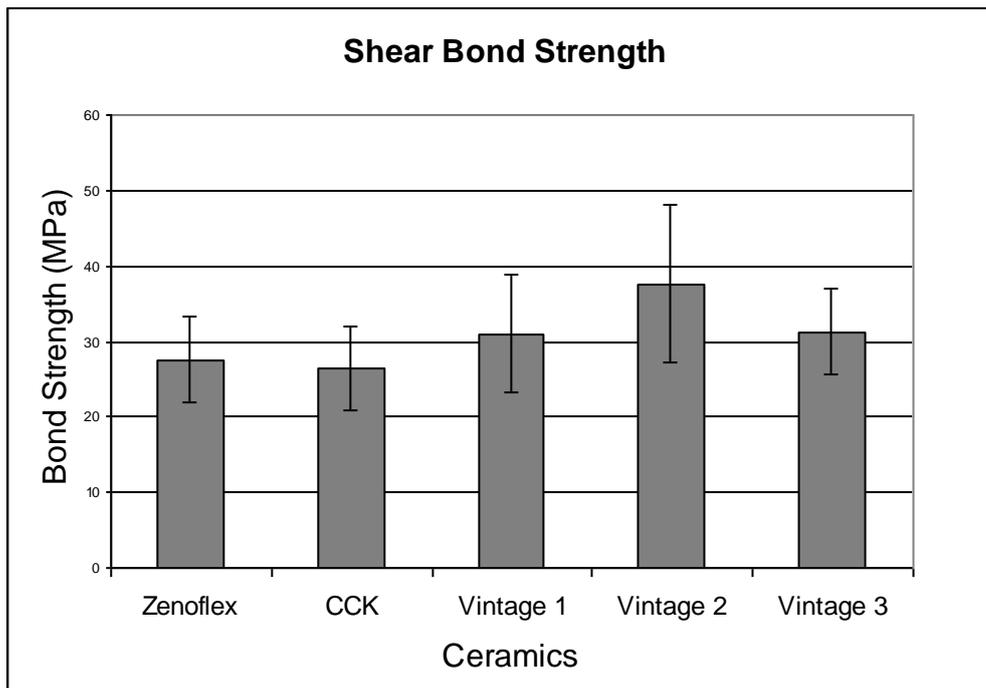
Figure 4.1: Mean shear bond strength of the 5 tested veneering ceramics. The vertical lines shows the standard deviation for each veneering ceramic.

One way ANOVA revealed a significant difference in the shear bond strength among the five tested veneering ceramics at $P < 0.05$. The Tukey HSD comparison test was used to make all pair comparison of mean shear bond strength of the 5 groups. The result of this comparison are presented in table 4.1.

The P values of the different comparison show that Zenoflex dimension, CCK, Vintage Zr1, and Vintage Zr3 were not significantly different. Vintage Zr2 had significantly higher mean bond strength than Zenoflex dimension and CCK groups.

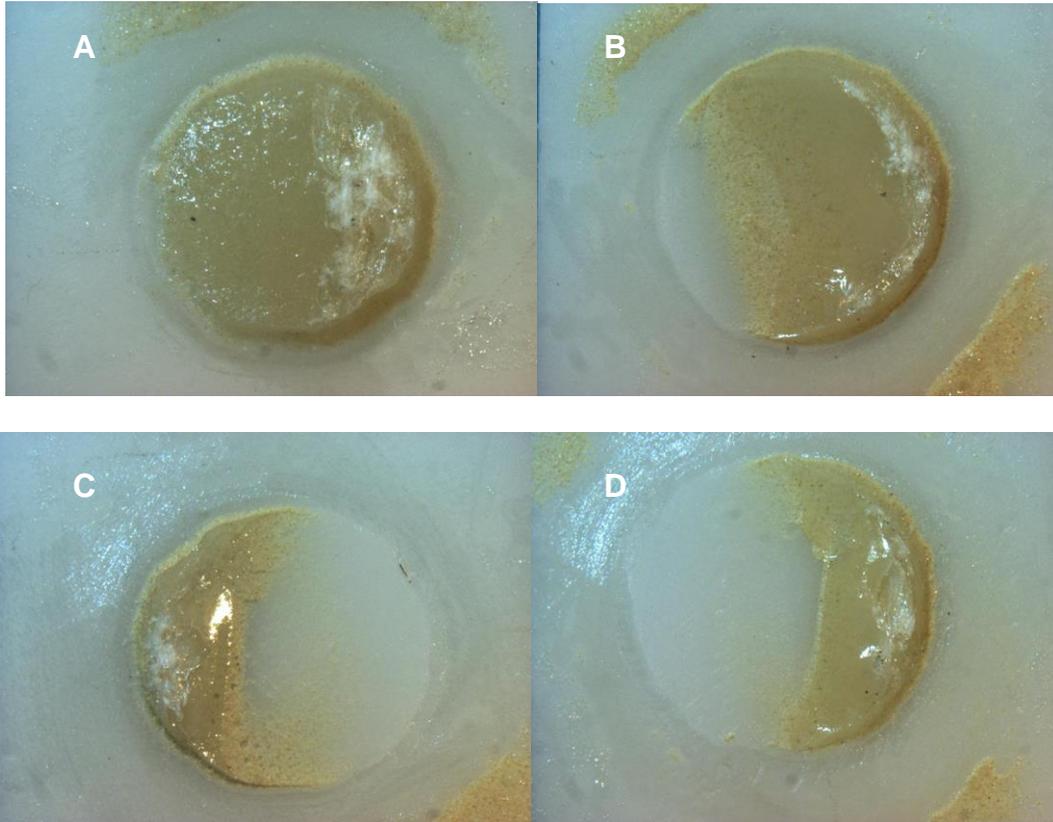
Figure 4.2: A and B cohesive fracture mode. C and D mixed fracture mode.

All of the groups demonstrated either cohesive or mixed fracture mode within the veneering ceramic (Figure 4.2). In Vintage Zr1 and Vintage Zr2 groups, 9 specimens from each group demonstrated a mixed failure mode while one specimen failed cohesively from each group. In Vintage Zr3 and CCK groups, 6 specimens (of each group) demonstrated mixed fracture mode and 4 specimens failed cohesively. In Zenoflex group, 8 specimens exhibited mixed fracture mode and 2 specimens failed cohesively.

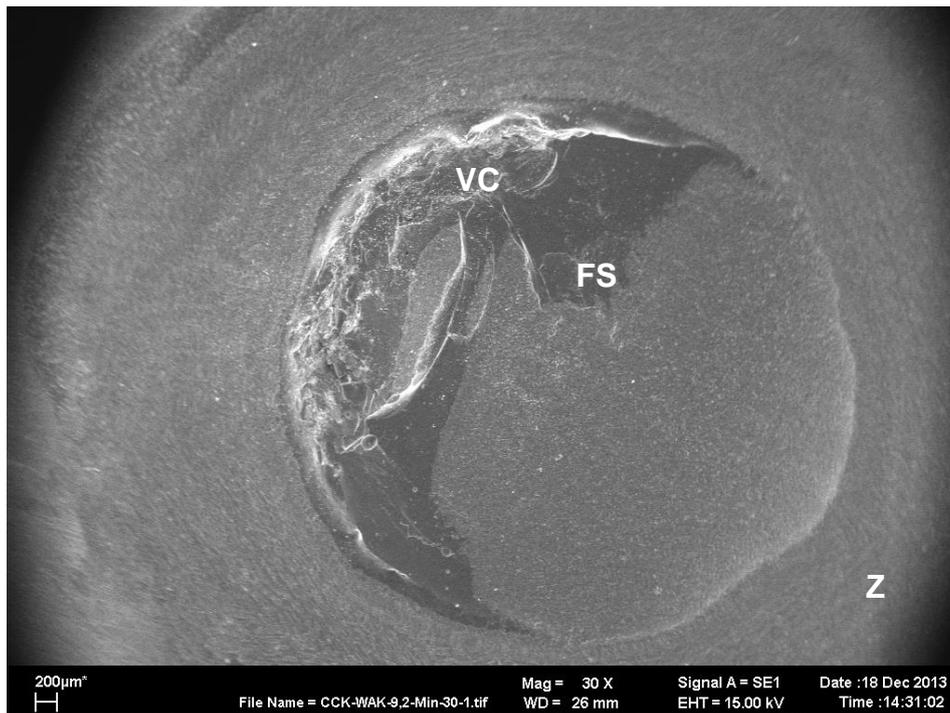
Figure 4.3: (30 magnification) SEM image (VC) is the veneering ceramic, (z) is the zirconia plate and (FS) is the fracture surface.

Figure 4.3 demonstrates the zirconia plate, veneering ceramic, and the fracture surface.

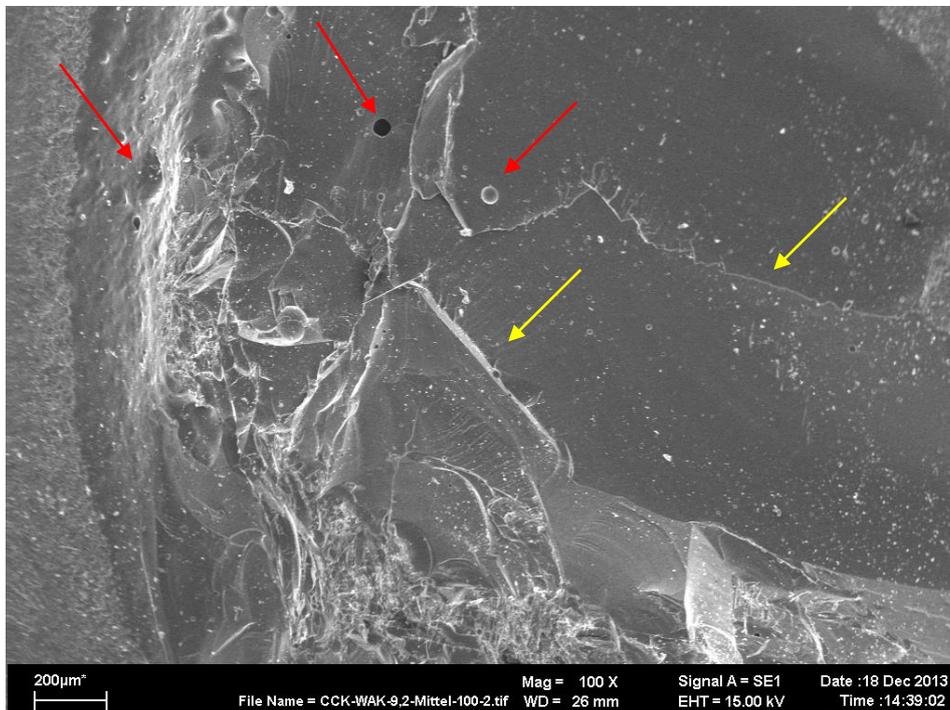
Figure 4.4: (100 magnification) SEM image of a fractured surface, yellow arrows point at the fracture lines, and red arrows point at defects in the veneering ceramic.

Generally, SEM images of the examined specimens are characterized by several inherent defect (porosity) (Figure 4.4, 4.5), irregular crack lines (Figure 4.4, 4.7) and detached veneering ceramic crystalline (Figure 4.6).

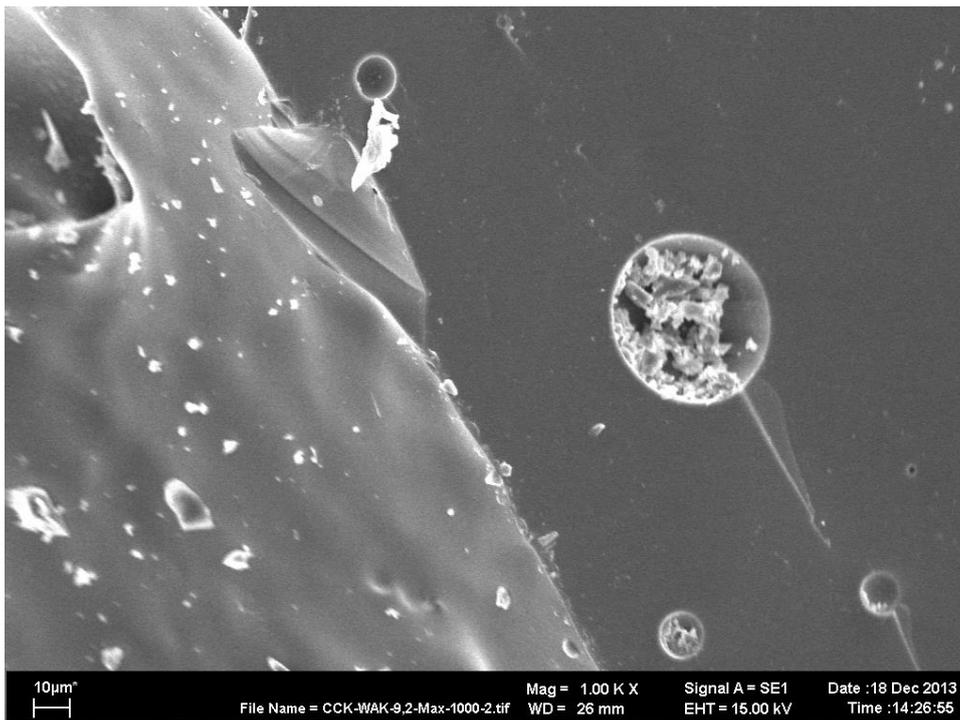
Figure 4.5: (1000 magnification) SEM image shows the pores in the veneering ceramic.

SEM evaluation revealed that the fracture is originated in the veneering ceramic layer through multiple porosities. Irregular fracture lines indicated that the fracture was caused by the porosities within the veneering ceramic which acted as a stress concentrators. Aboshelib et al. 2008 found porosities free veneer after SEM examination of zirconia press-on

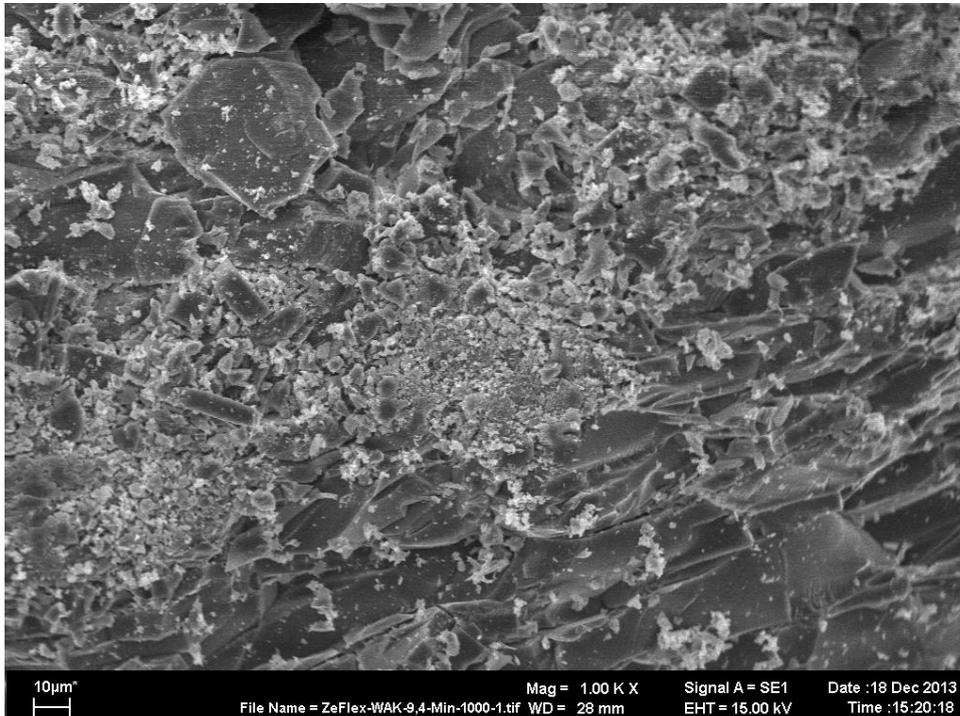
Figure 4.6: (1000 magnification) SEM image of fracture surface shows deattached crystalline of the veneering ceramic.

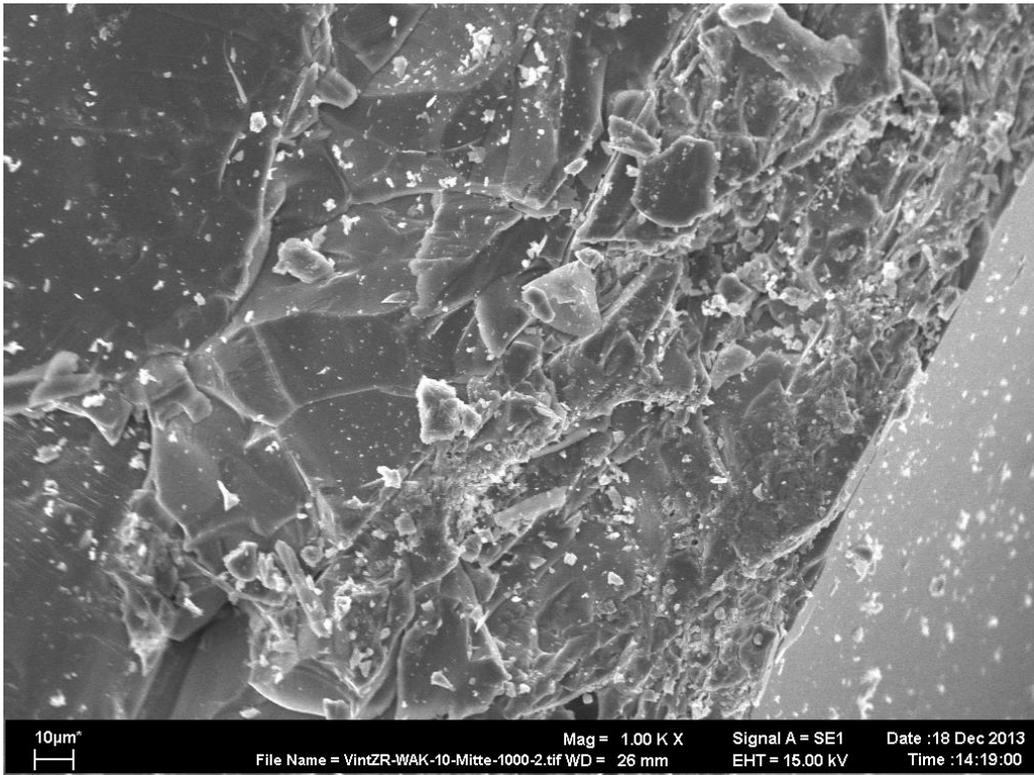
Figure 4.7: (1000 magnification) SEM image shows irregular fracture lines
